**ELECTRONICS COORDINATING OF**  
**SHIP PREPARATION**  
**and**  
**TARGET INSPECTION**

**FINAL REPORT**  
**TESTS ABLE AND BAKER**

**VOLUME 2**  
**PHOTOGRAPHIC RECORD**

**DIRECTOR OF SHIP MATERIAL**  
**JOINT TASK FORCE ONE**  
**OPERATION CROSSROADS**

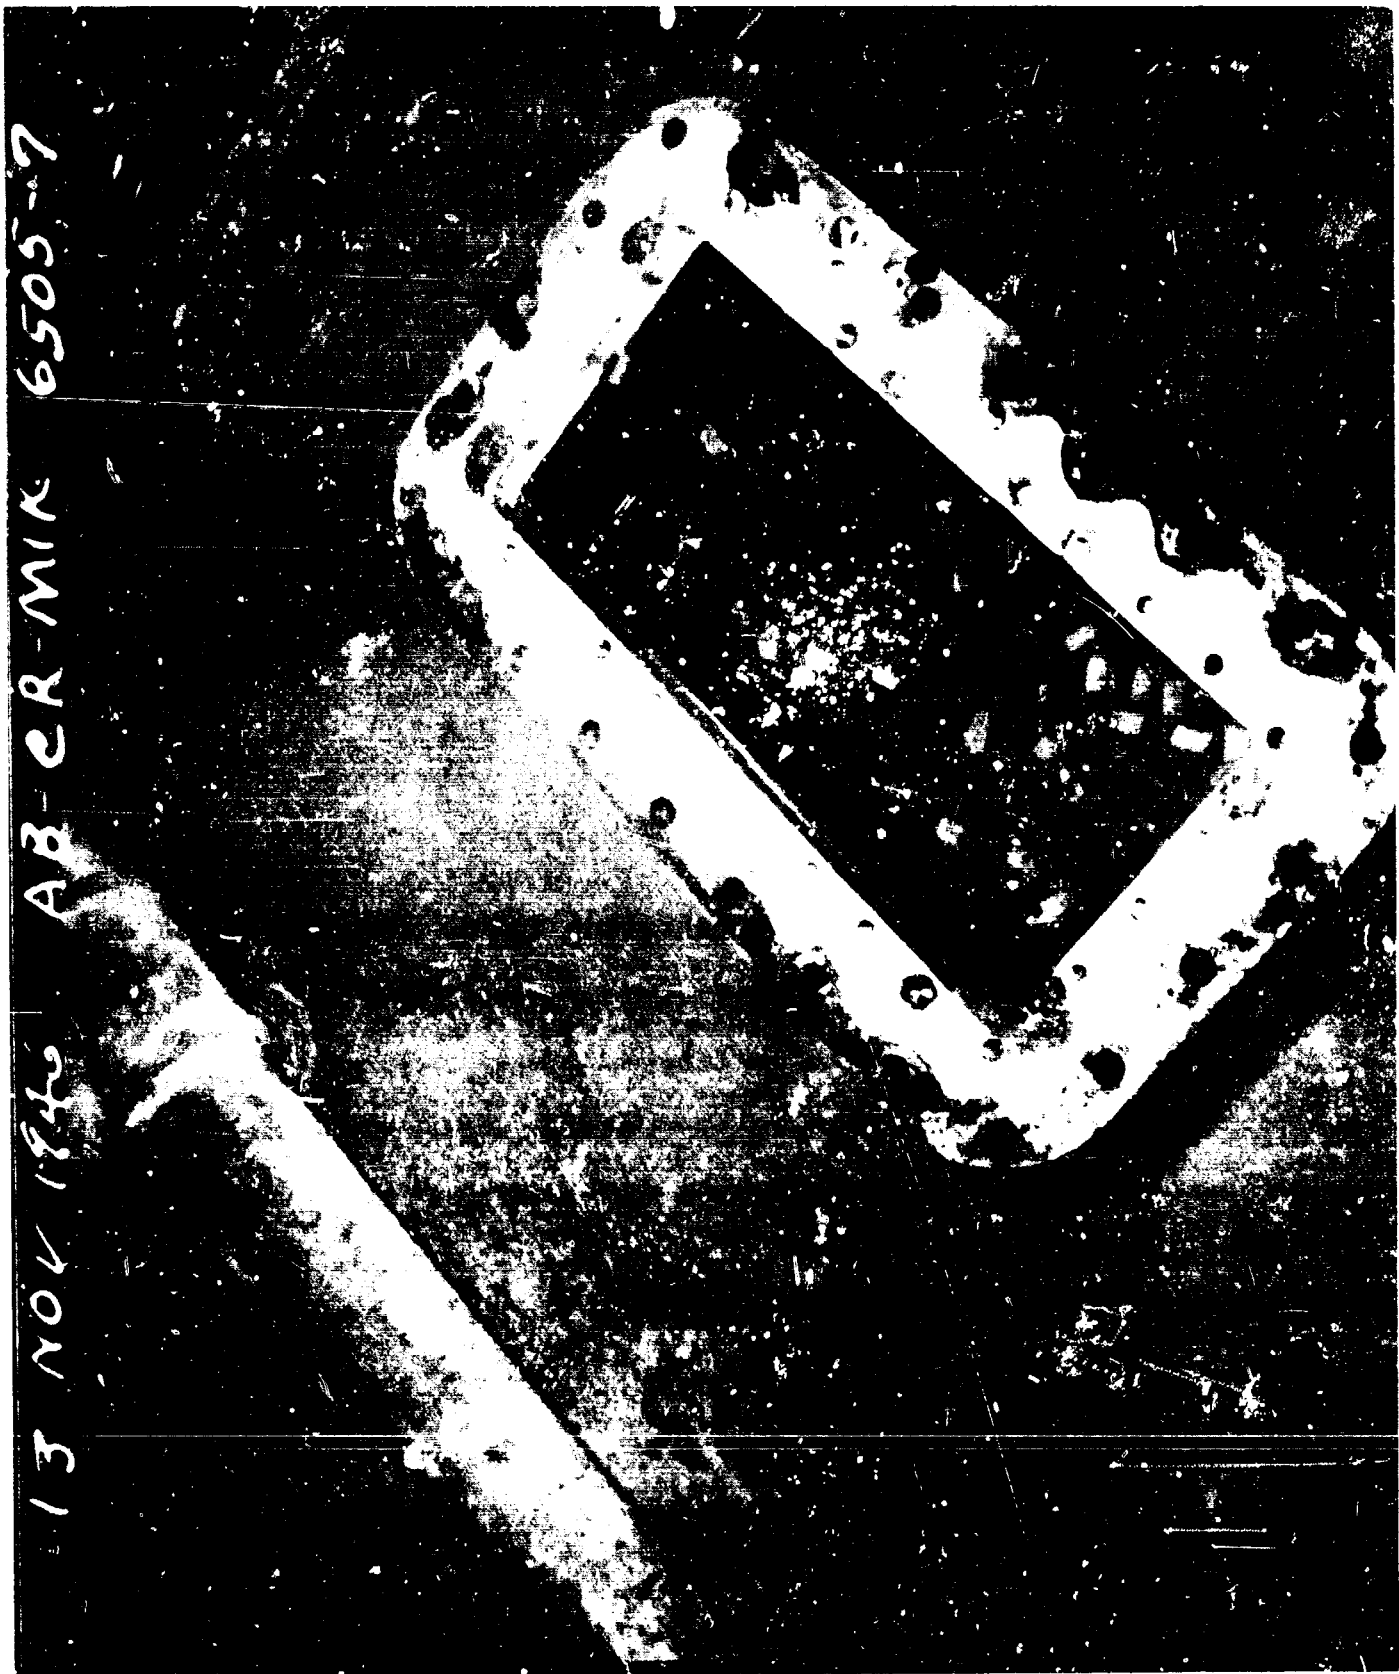
POST BAKER - NGA PROJECTOR. Case with crystal assembly and cover plate removed. Note broken and loose crystals.

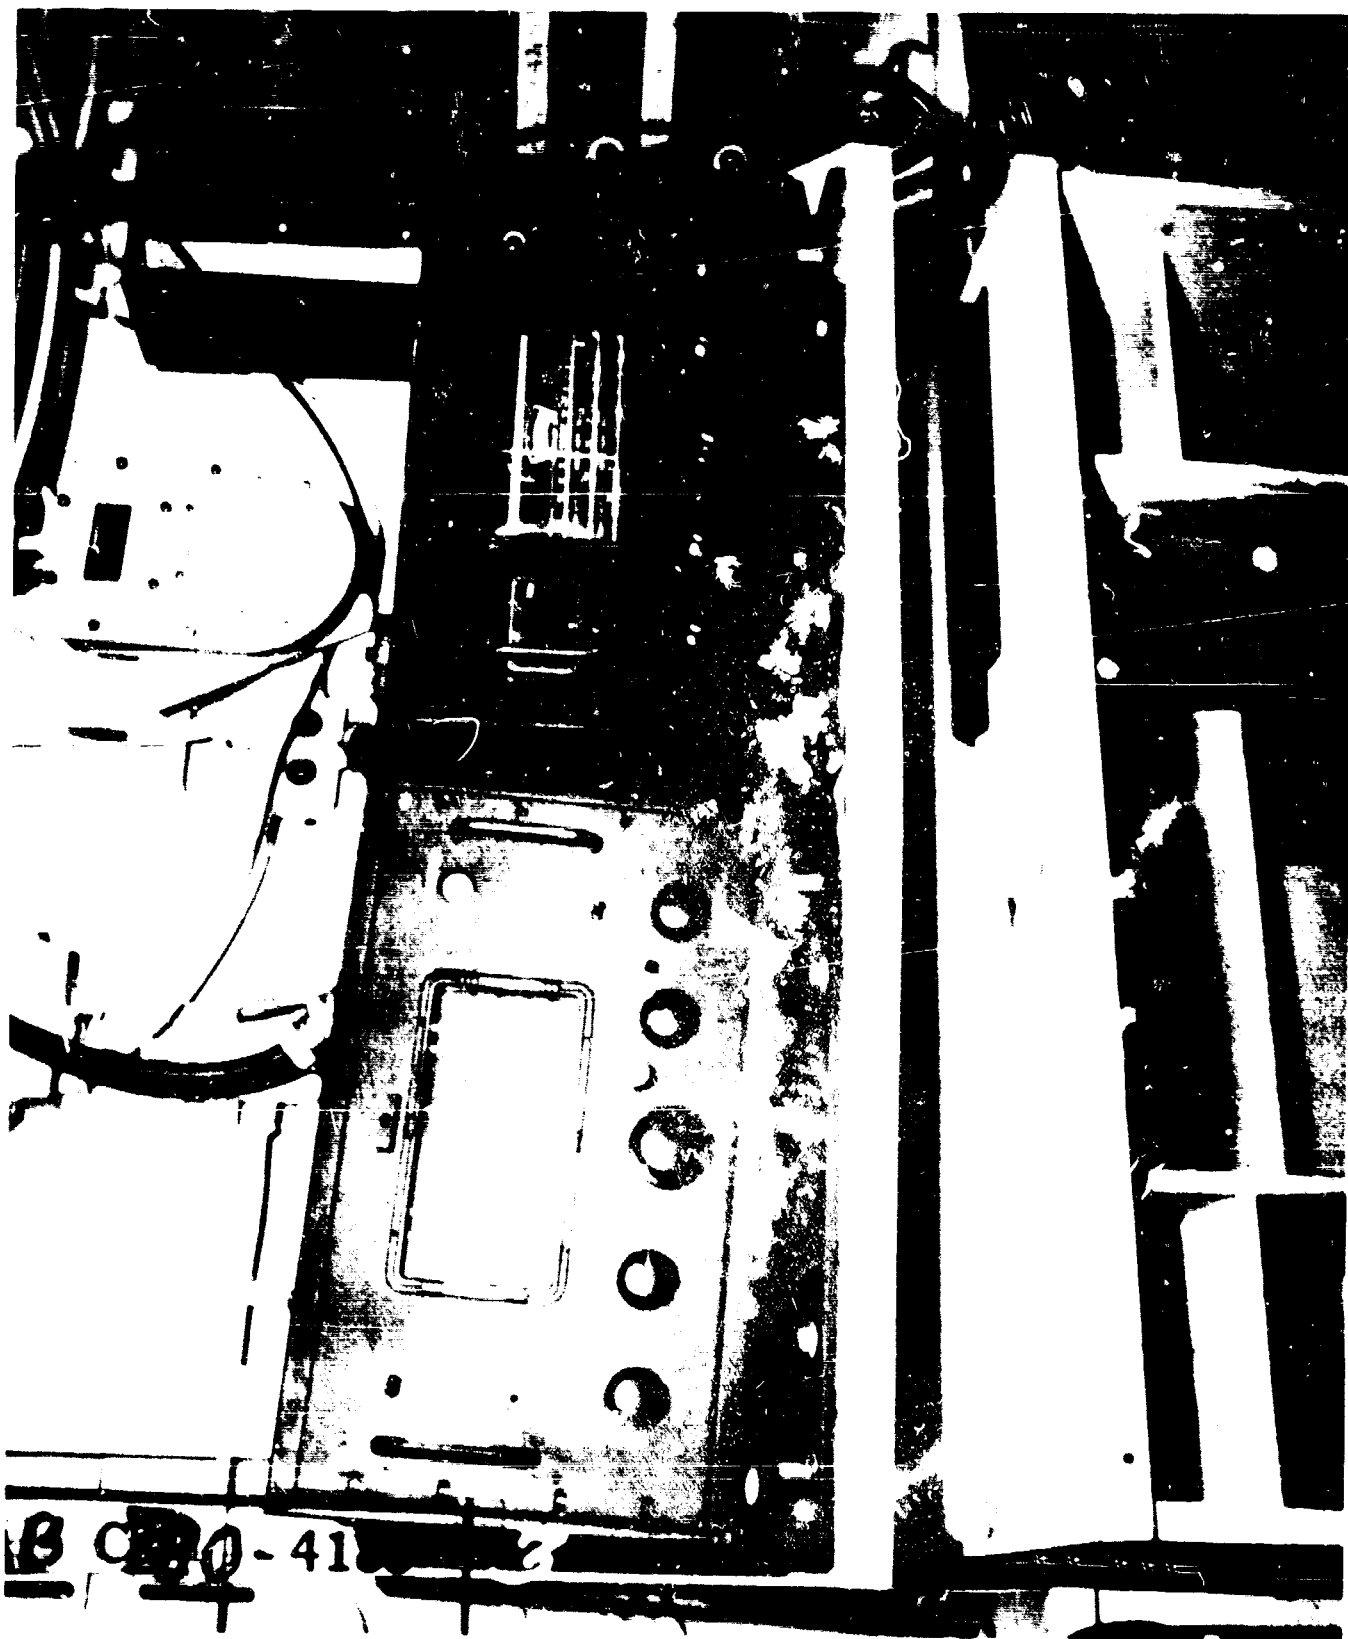
POST BAKER - RBO'S IN RADIO I. Shock mounts failed on receiver to left. No other damage to receiver.
